Chairside fabrication of a nano-ceramic hybrid composite endocrown for a severely damaged molar after endodontic treatment

Drs Alejandro Bertoldi Hepburn & Matías Scazzola, Argentina

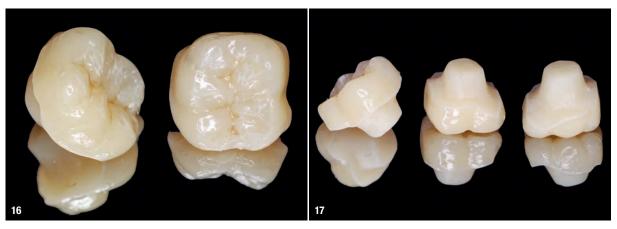
Fig. 16: Occlusal surface of the finished endocrown. **Fig. 17:** Inner surface of the endocrown. Note the extensive portion for bonding in the enlarged pulp chamber preparation of the molar.

After general design of the restoration, the impression file was transferred to another design program (exocad) in order to digitally generate the restoration (Fig. 13). After completion of the digital design of the endocrown, the file was returned to the CEREC system. Once this had been done, the restoration was fabricated by milling a block of a highly filled nanoceramic hybrid material (Grandio blocs, VOCO; Fig. 14). The processing of the composite block took about 10 minutes. Afterwards, a light-curing characterisation material (FinalTouch, VOCO) was applied to pretreated furrows and fissures (Fig. 15), lightcured and occlusally covered with a packable or flowable composite (or a mixture) and light-cured. The endocrown was polished with rubber points and brushes (Figs. 16 & 17).

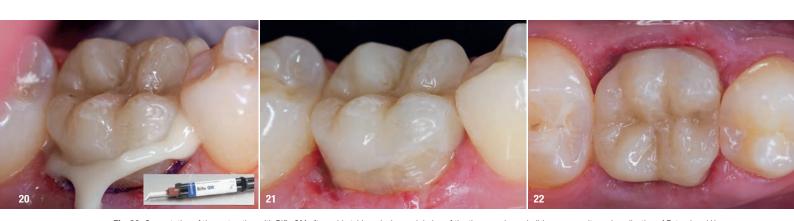
Fig. 20: Cementation of the restoration with Bifix QM after acid etching, rinsing and drying of the tissue and core build-up composite and application of Futurabond U.

Fig. 21: After placement of the restoration and removal of excess adhesive cement and polishing of the margins and the surface. Fig. 22: After polishing of the occlusal surface. The gingivae had been injured and needed to heal.

The newly covered cavity was etched with 37% phosphoric acid, rinsed with water, dried and pretreated with Futurabond U. A dual-curing cementation composite material (Bifix QM, VOCO) was applied to the endocrown (Fig. 20) so that it could be luted in the tooth. After application of continuous light pressure,

it was fitted into place correctly. Excess cement was removed with micro-brushes from the lingual and buccal sides and with dental floss from the interproximal spaces. The material was then light-cured for 1 minute from the lingual and buccal sides. The margins were optimised with finishing diamond burs and polished with rubber points and brushes. The interproximal spaces were checked for excess material. The occlusion was checked, and no adjustments were needed (Figs. 21 & 22).
