# Posterior restorations using Admira Fusion

*Dr. James Robson (UK),  
Principal Dentist*

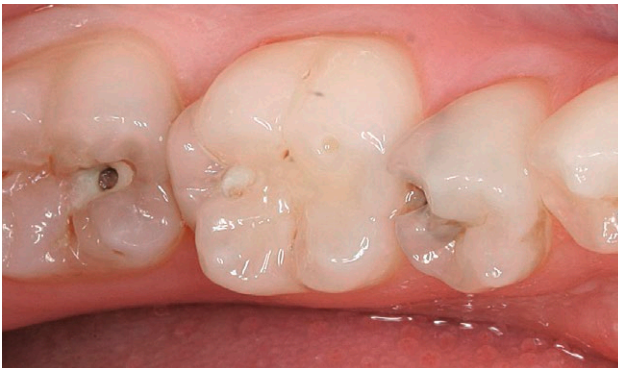
Fig. 1: Pre-operative occlusal view – caries noted 37 MO, 36 DO, 35 DO

Treatment was delivered on a quadrant by quadrant basis. This case study focuses on the delivery to the lower left quadrant. Caries was identified on 37, 36 and 35.

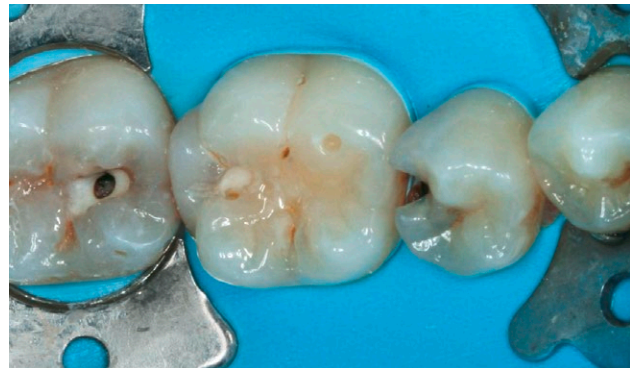
Fig. 2: Rubber dam isolation

Local anaesthetic was delivered to the lower left sextant and teeth were isolated with latex-free rubber dam (Unodent), Hygienic clamps (Coltène) on 37 and 34. Caries was removed through cavity preparation from 37 MO, 36 DO and 35 DO (Fig. 3). The cavities were checked with VOCO Caries Marker.

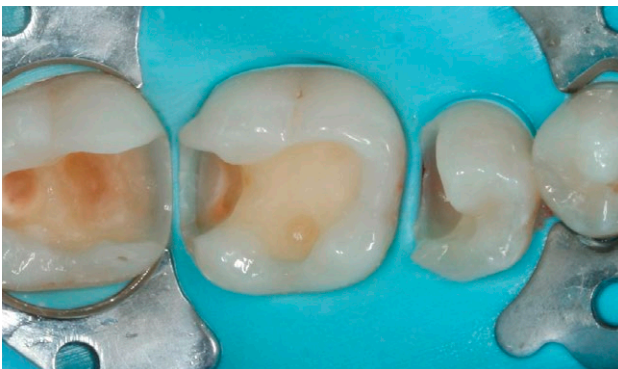
Fig. 3: Cavity preparation of 37 MO, 36 DO, 35 DO performed and finished with AquaCare Twin

The cavities were treated with Aquacare Twin (Velopex International) with 29µ aluminium oxide at a pressure of 3 bar and then treated with Sylc at a pressure of 2 bar to increase retention and for final cavity cleaning before bonding. This has become an indispensable part of my routine as it guarantees a plaque-free substrate to bond to.

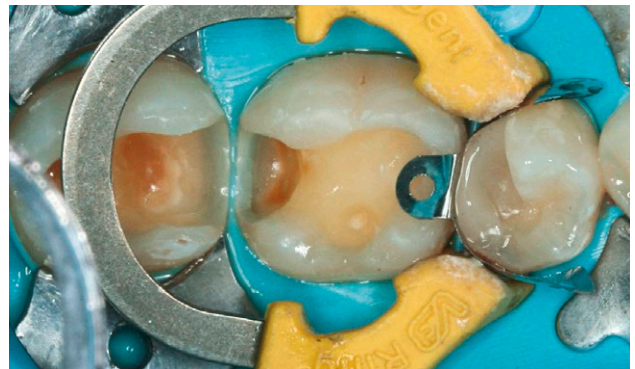
Fig. 4: Matrix Band placement

A Palodent V3 (Dentsply Sirona) medium 5.5 mm matrix was placed on 35 and a medium wedge applied to ensure a good tight contact.

The Palodent V3 matrix was then removed and the stages were repeated on 36 DO then 37 MO separately, using a medium 5.5 mm matrix with a small wedge on each occasion.

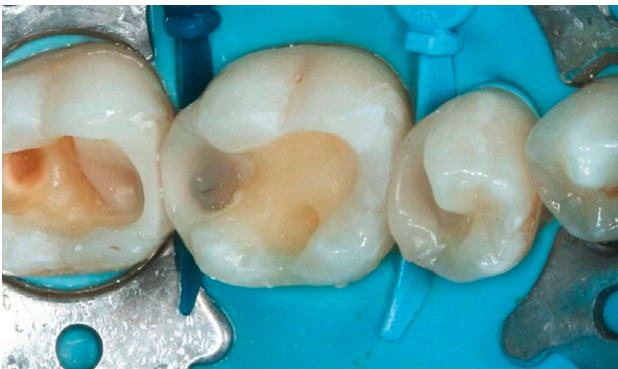
Fig. 5: Placement of walls and removal of matrices and rings

VOCO Admira Fusion A3 universal nano-hybrid ORMOCER restorative material was applied to each proximal contact independently using an American Eagle titanium nitride teardrop instrument. It was cured on each occasion, converting each cavity into an occlusal (Black's Class 1).

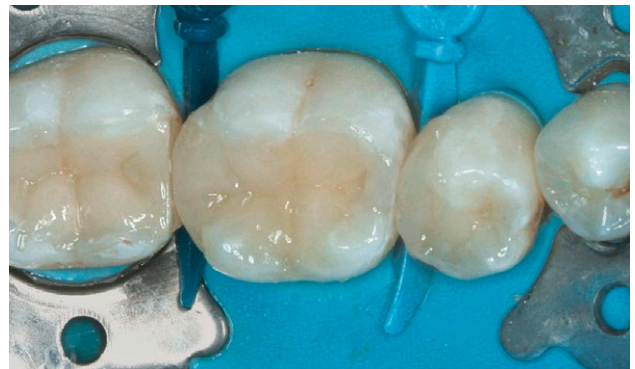
Fig. 6: Cusp by cusp build up complete

The tooth morphology was then restored on a cusp by cusp basis with VOCO Admira Fusion A3 universal nano-hybrid ORMOCER restorative material using American Eagle titanium nitride instruments. Fine detail was achieved using the Fissura (LM-Arte). The VALO curing light was used for polymerisation.

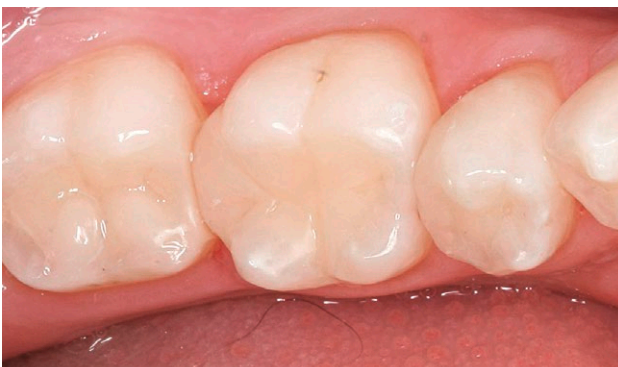
Fig. 7: Final result after occlusal control and polishing

Basic shaping was then performed with an NSK X600L air turbine using fine diamond burs (yellow band) and pre-polished with a VOCO Dimanto one step diamond polisher run at slow speed with water spray in an NSK Z25L hand-piece. Finally, a high lustre was achieved by polishing with ShapeGuard Composite Plus (Coltène) 23SG11RA (pink) then 24SG11RA (blue).

The rubber dam was then removed and occlusal checks performed with Arti-Check 40µ articulating paper (Dr Bausch) and 8µ shimstock (Hanel) and final adjustments made. Contacts were cleared with Satinfloss (Oral-B) and polished with Epitex tapes (GC).
