Best practices for class II restorations

Innovative thermoviscous bulk-fill composite

Susan McMahon, DMD, AAACD, FAGD

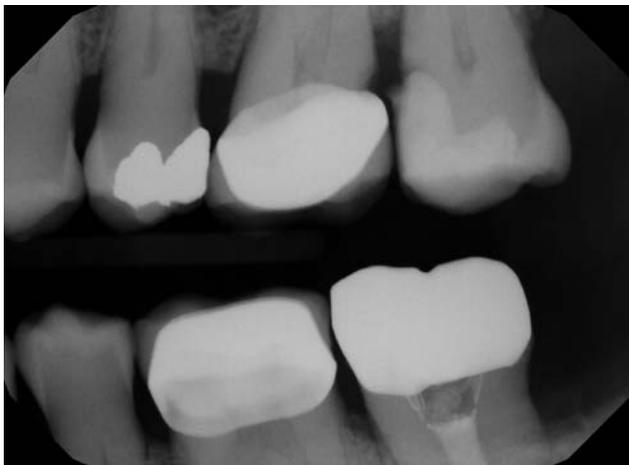
Figure 1: Radiograph of failing class II composite restoration

The upper left second molar has a failing class II mesial-occlusal restoration (figure 1). As seen on the black and white radiograph, there is an open mesial contact and recurrent decay at the base of the proximal box. This is typical of a class II composite restoration's

most common failure.

The upper left first molar has recurrent decay at the distal crown margin as well. The open proximal contact may have contributed to the failure of this crown.

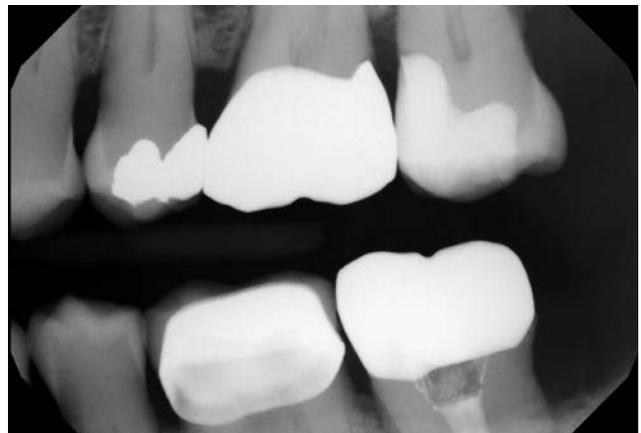
Figure 2: VisCalor bulk restoration with sealed gingival margin and well-contoured and tight interproximal contact

The failing composite restoration was removed along with the recurrent decay. A new restoration was placed using VisCalor bulk. The flowability of the material resulted in the floor of the box being well adapted and the gingival margin being sealed. The mesial contour is anatomically correct, and the proximal contact is tight. The sculptability of the material allowed for packing against the sectional matrix and carving of anatomy.

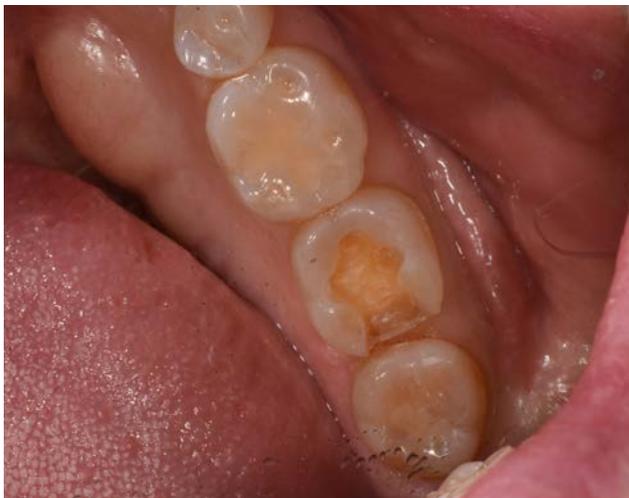
Figure 3: Class II DO preparation of mandibular left second molar

The lower left second molar was prepared for a class II composite restoration (figure 3). A sectional matrix band was placed and wedged. The preparation was etched, and adhesive was placed and cured. The VisCalor bulk was heated in the heating gun and then dispensed into the base of the box while in its flowable state. Note the complete adaptation of the material to the walls of the prep and matrix band (figure 4). The rest of the cavity was filled while the material was in its flowable state.

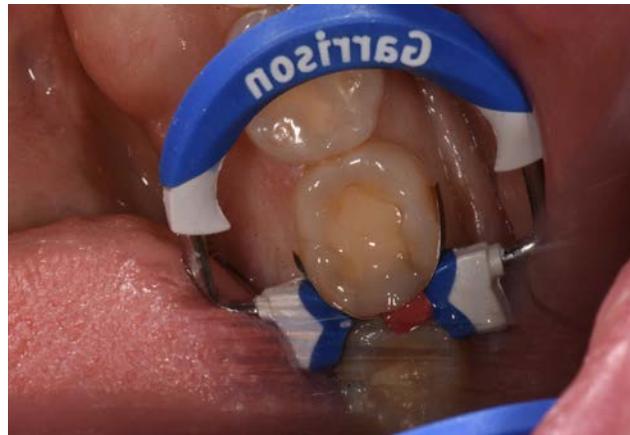
Figure 4: Class II DO preparation banded and wedged. VisCalor bulk is heated and flowed into the distal box, adapting well to the walls, floor, and matrix band.

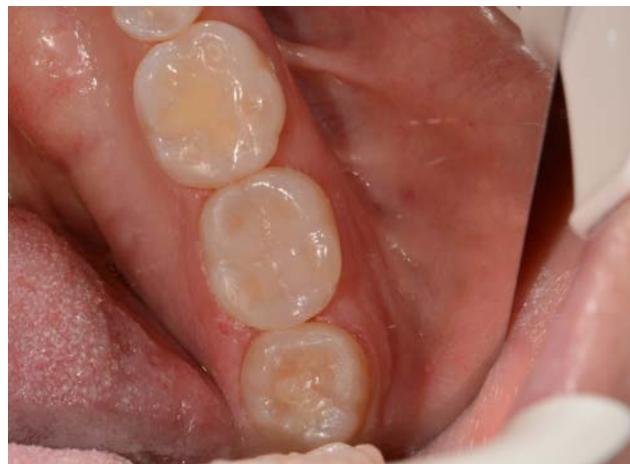
Figure 6: Completed class II thermoviscous bulk-fill composite with VisCalor bulk

The composite became sculptable when cooled to body temperature (figure 5). The completed class II composite restoration is shown in figure.⁶ The distal marginal ridge, distal fossa, central groove, and triangular ridges have been sculpted into the restoration. The distal proximal contact is tight and properly contoured. **DE**
